Damage to Highway Bridges Caused by the 2011 Tohoku-Oki Earthquake

– JAPAN BRIDGE ENGINEERING CENTER –

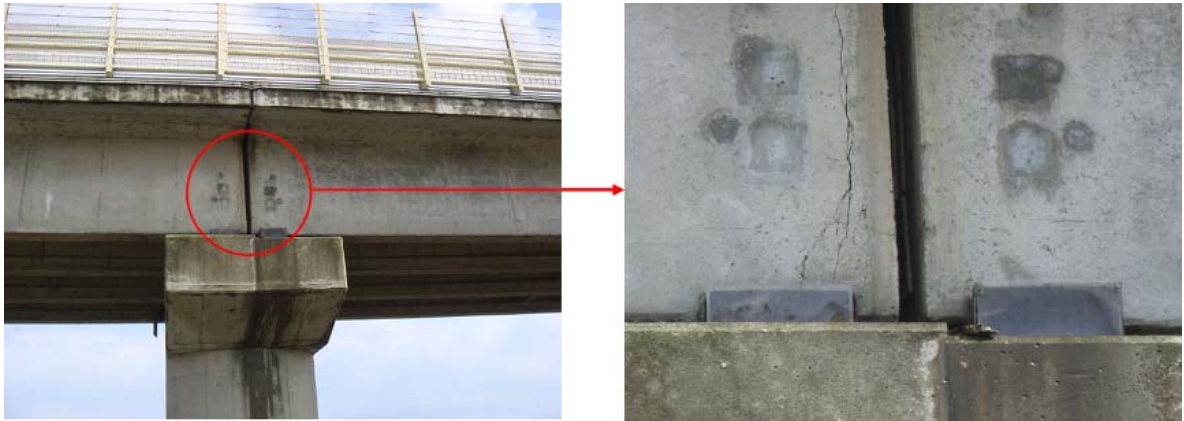
Photo-1 Cracking of ends of main girders (supporting point) (principal local road, Shiogama-Watari Line; Yuriage Bridge, Natori City, Miyagi Pref.)

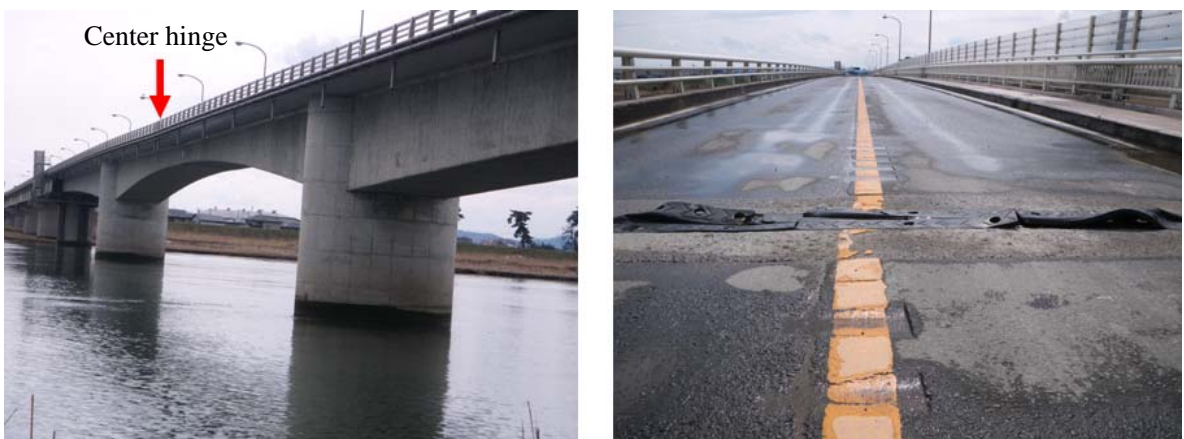
Photo-3 Displacement at the center hinge of rigid-frame bridge (principal local road, Shiogama-Watari Line; Yuriage Bridge, Natori City, Miyagi Pref.)

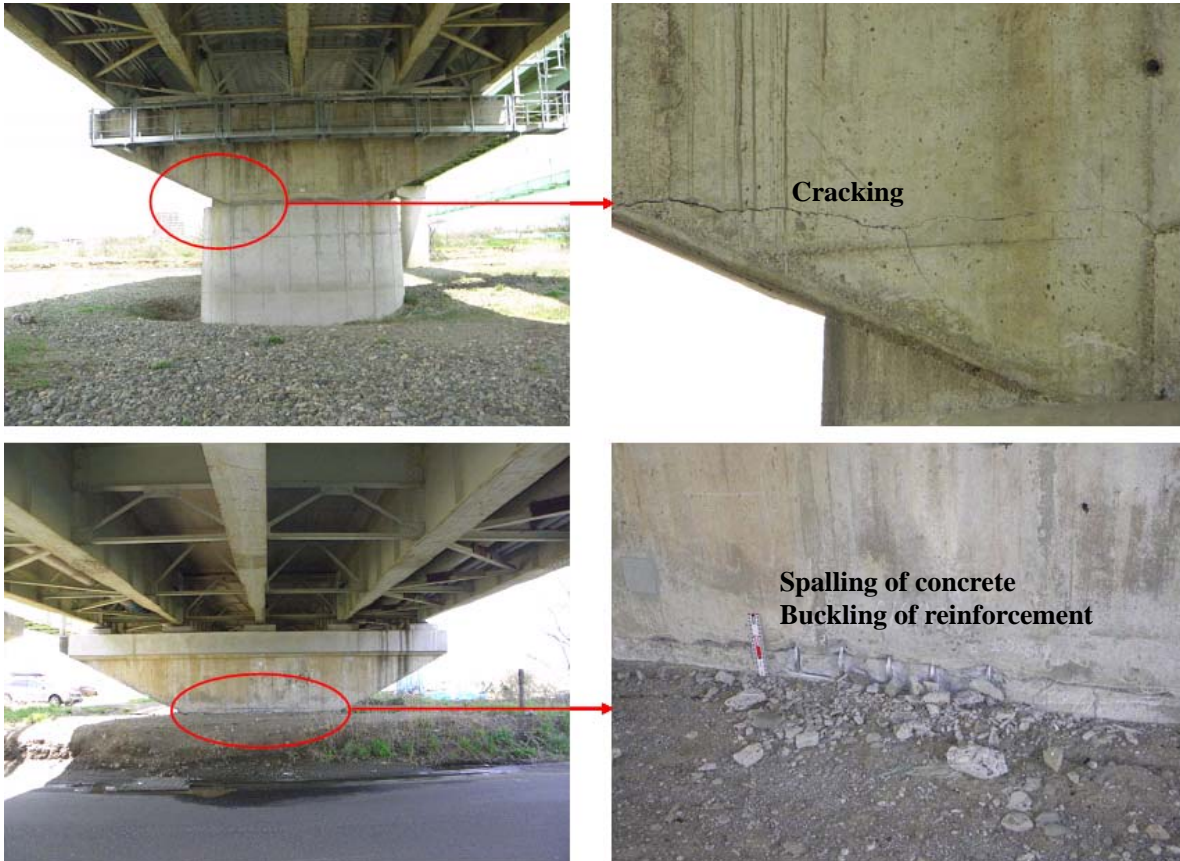
Photo-4 Cracking of RC pier, spalling of concrete, and buckling of reinforcement (Rte. 4, Natori Bridge, Natori City, Miyagi Pref.)

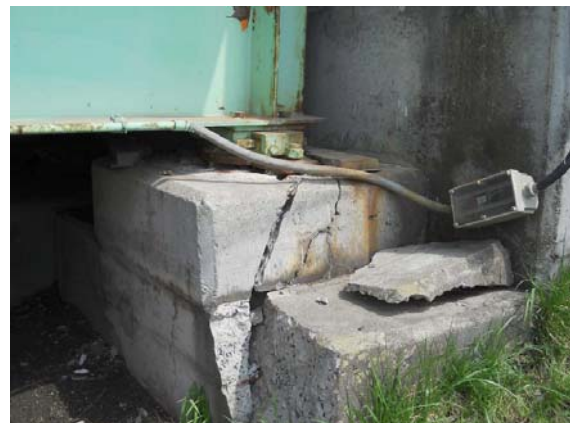
Photo-5 Cracks in abutment (Rte. 45, pedestrian bridge at Tennoh Bridge, Ishinomaki City, Miyagi Pref.)

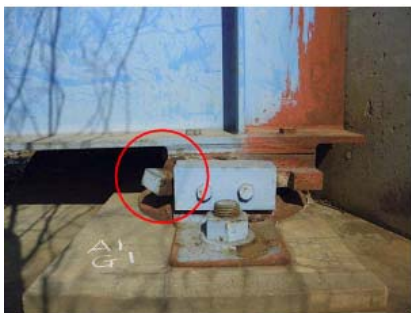
- Deformation/fracture and abnormal expansion gap of upper shoe stopper (Photo-6)
- Deformation of anchor bolts (Photo-7)
- Fracture of set bolts (Photo-8)
- Cracking and loss of shoe seat mortar (Photo-9)
- Dislodgment of expansion joint protector (Photo-10)

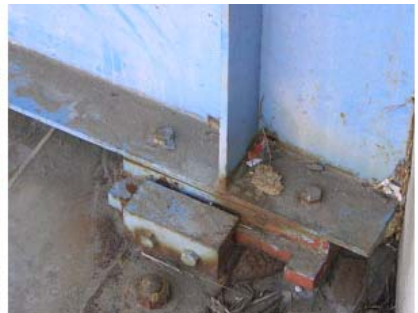
Abnormal gap (movable bearing)

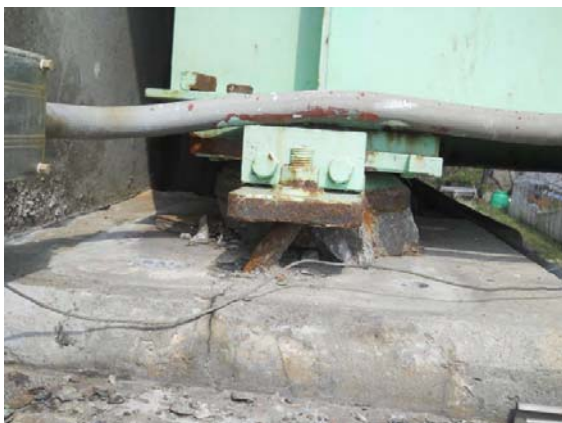
Photo-7 Deformation of anchor bolts (Rte. 45, pedestrian bridge at Tennoh Bridge, Ishinomaki City, Miyagi Pref.)

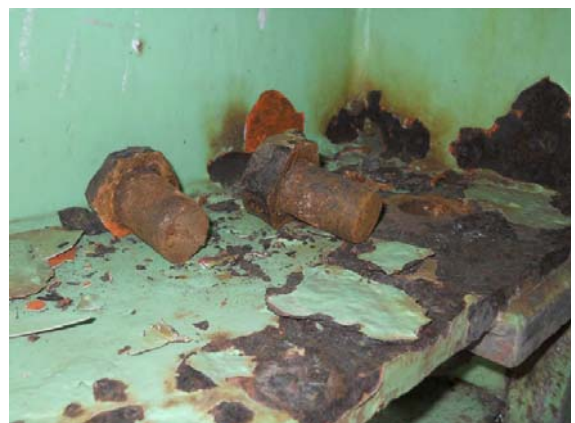
Photo-8 Fracture of set bolts (Rte. 45, Tennoh Bridge, Ishinomaki City, Miyagi Pref.)

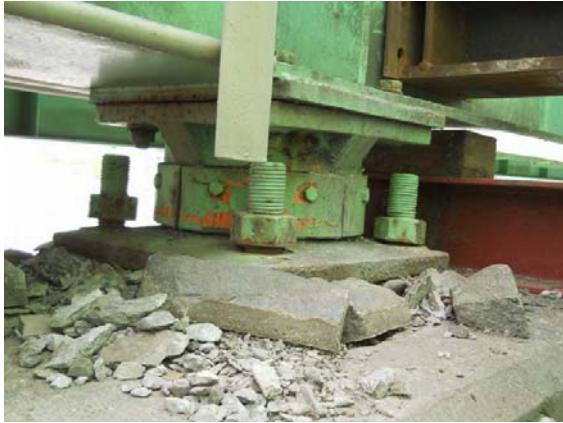
Photo-9 Cracking/loss of shoe seat mortar
(Rte. 45, pedestrian bridge at Tenuoh Bridge,
Ishinomaki City, Miyagi Pref.)

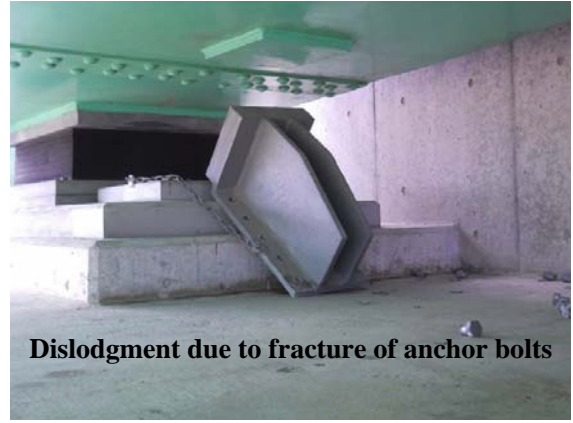
Dislodgment due to fracture of anchor bolts

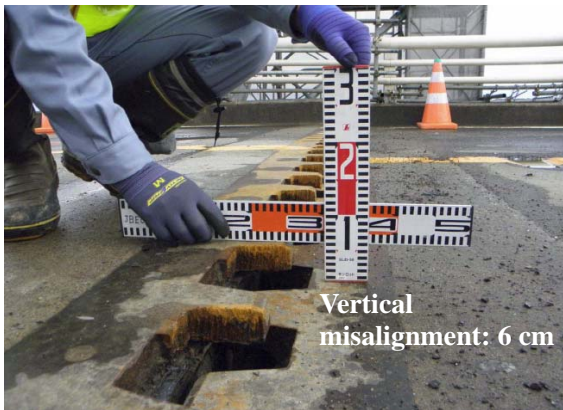
Vertical
misalignment: 6 cm

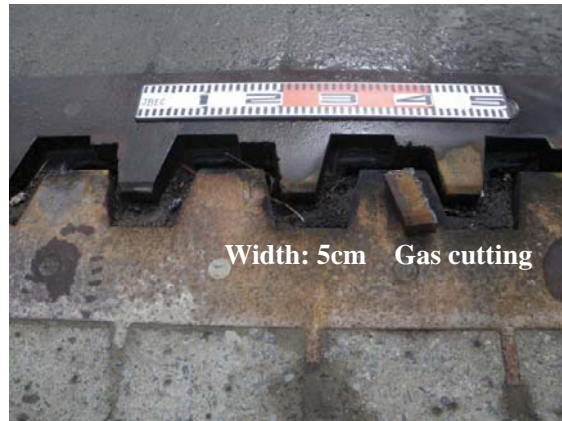
Photo-13 Abnormal expansion gap of expansion joint perpendicular to bridge axial direction
(principal local road, Shiogama-watari Line; Yuriage Bridge, Natori, Miyagi Pref.)

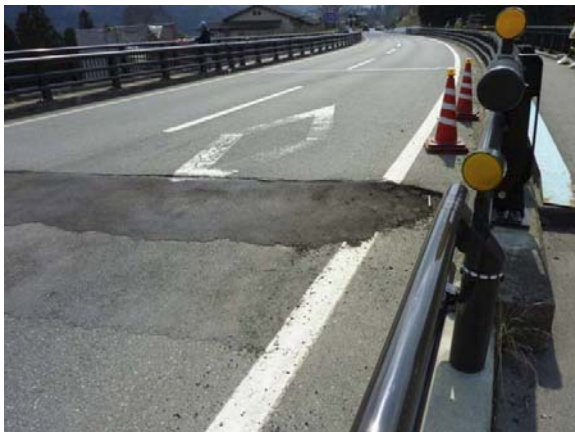
Difference of surface level in roadway section
(after emergency repair by construction of ramp)

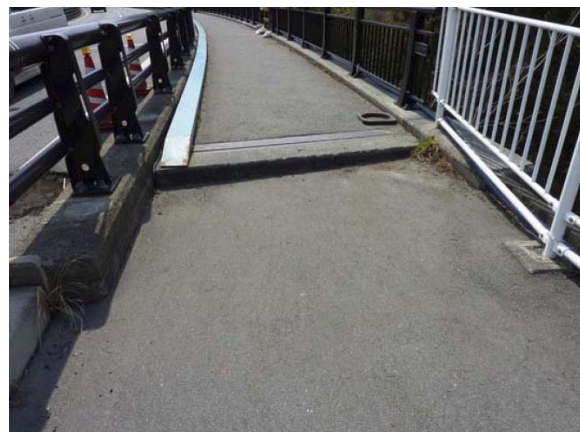
Difference of surface level in pedestrian section
(difference of more than 2 cm)

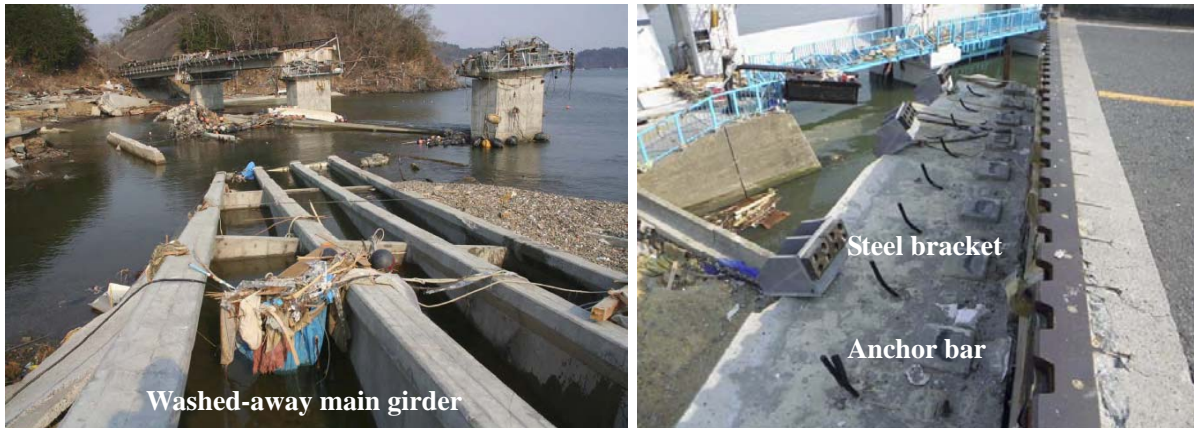
Photo-15 Washed-away main girders (PCT girders) (Rte. 45, Utatsu Bridge, Minamisanriku Town, Miyagi Pref.)

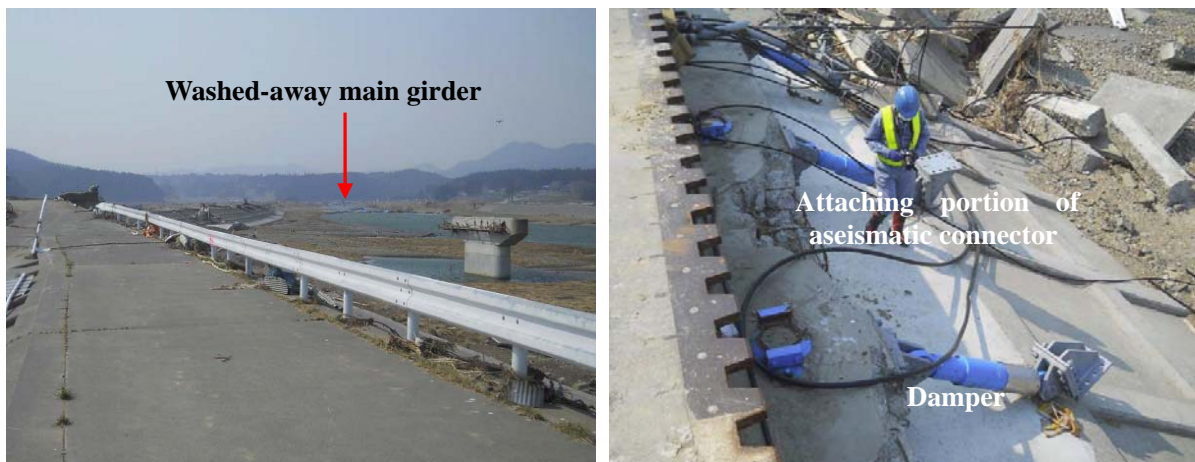
Photo-16 Washed-away main girders (steel plate girders) (Rte. 45, Koizumi Bridge, Kesenuma City, Miyagi Pref.)

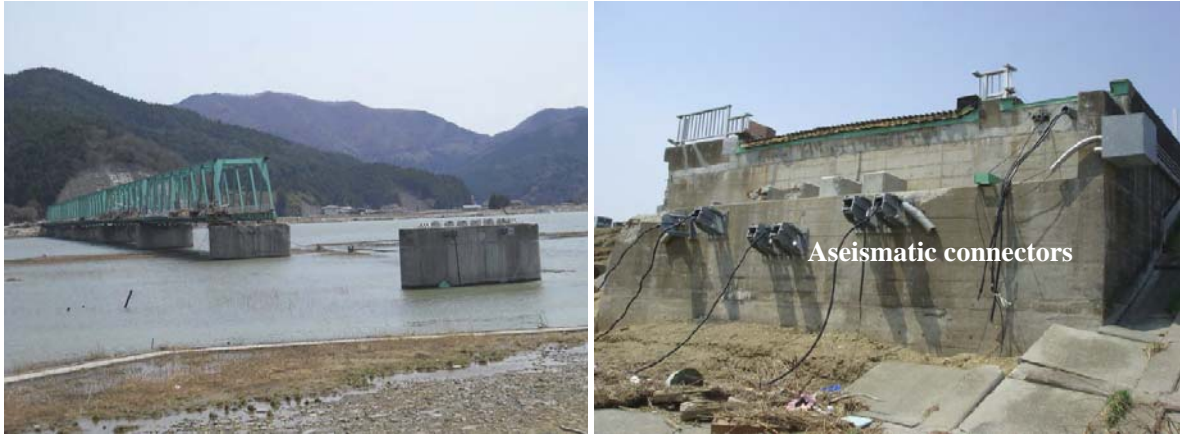
Photo-17 Washed-away main trusses (Rte. 398, Shin-Kitakami Bridge, Ishinomaki City, Miyagi Pref.)

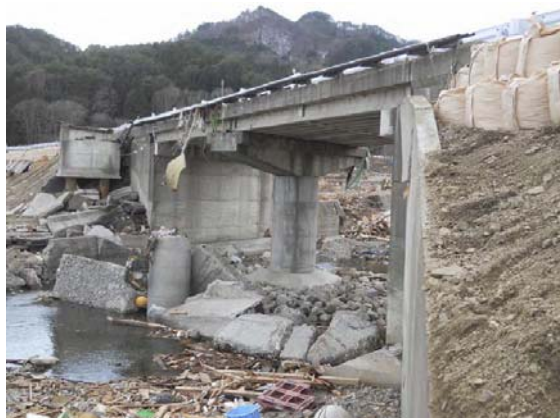
Photo-19 Washed-away main girders (H-shape steel girders) of bridge-side pedestrian bridge (Rte. 45, pedestrian bridge at Namiita Bridge (inbound side), Otsuchi Town, Iwate Pref.)

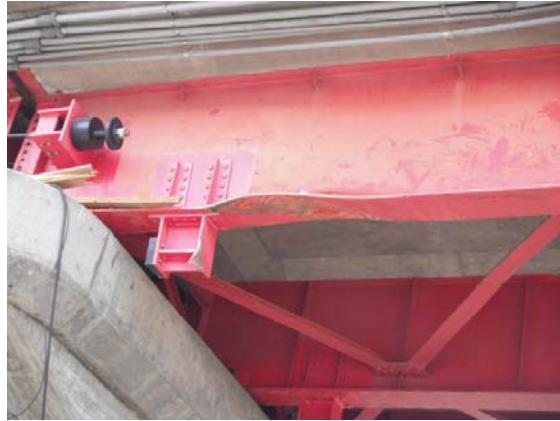
Photo-20 Main girder deformed by impact of floating debris (Rte. 45, Katagishi Bridge, Kamaishi City, Iwate Pref.)

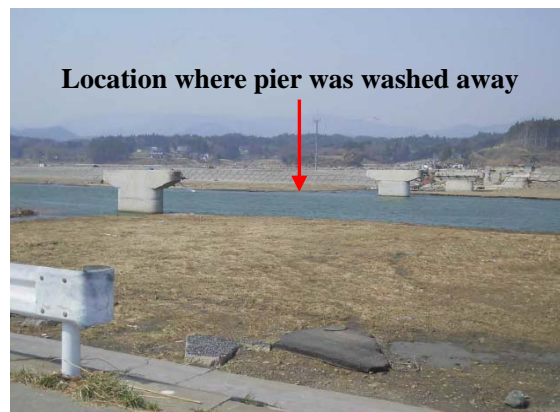
Photo - 21 Washed-away pier (Rte. 45, Koizumi Bridge, Kesenuma City, Miyagi Pref.)

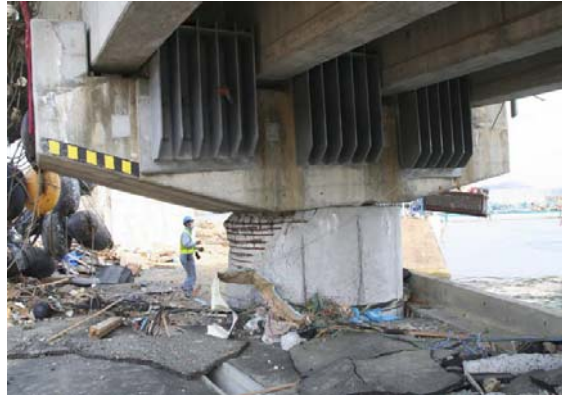
Photo-22 Damaged pier (Rte. 45, Utatsu Bridge, Minamisanriku Town, Miyagi Pref.)

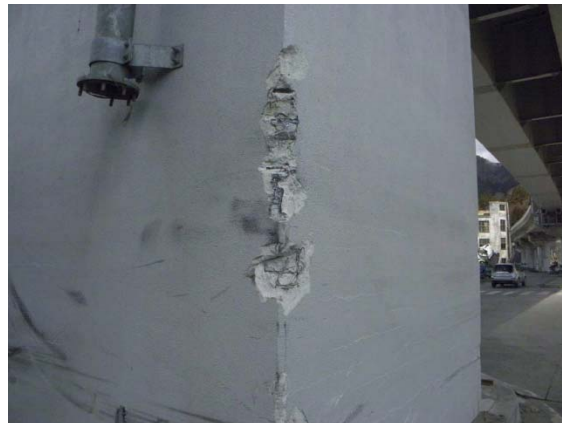
Photo-23 Damage to pier by impact of floating debris (Rte. 45, Kamaishi Viaduct, Kamaishi City, Iwate Pref.)

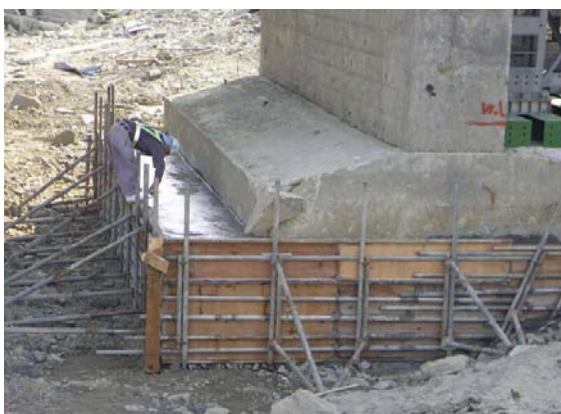
Concrete placing in the scoured part

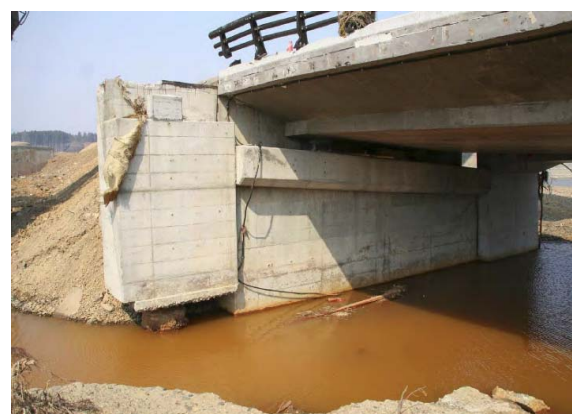
Abutment of pedestrian bridge showing an exposed foundation pile

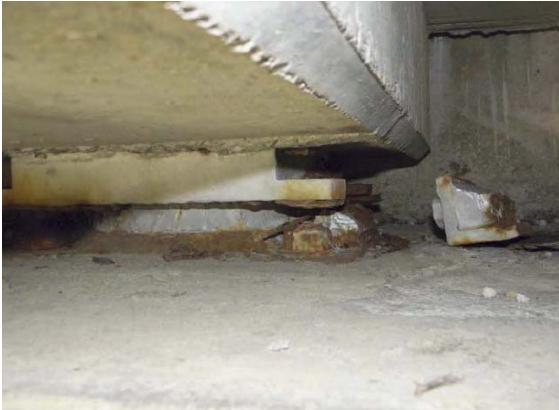
Photo-26 Deformation/fracture of bearing side block
(Rte. 45, Utatsu Bridge, Minamisanriku
Town, Miyagi Pref.)

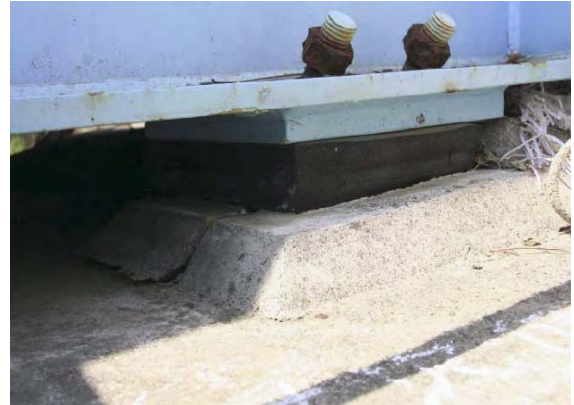
Photo-27 Deformation/pulling out of anchor bolts
(Rte. 45, pedestrian bridge at Osawa
No.2 Bridge (inbound side), Kesenuma
City, Miyagi Pref.)

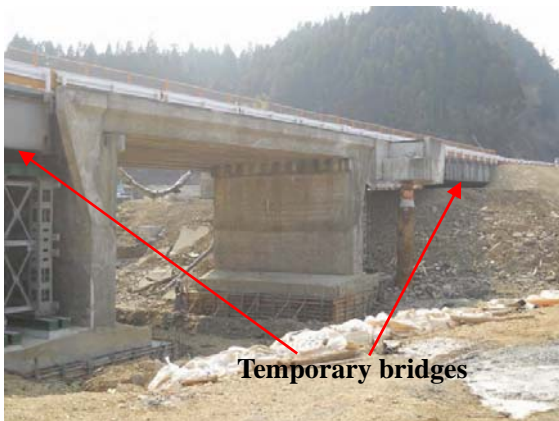
Temporary bridges constructed over areas where approach embankment was washed away.
